NIST TN 1658

Impact of Sprinklers on the Fire Hazard in Dormitories: Sleeping Room Fire Experiments

Daniel Madrzykowski
William D. Walton

January 2010

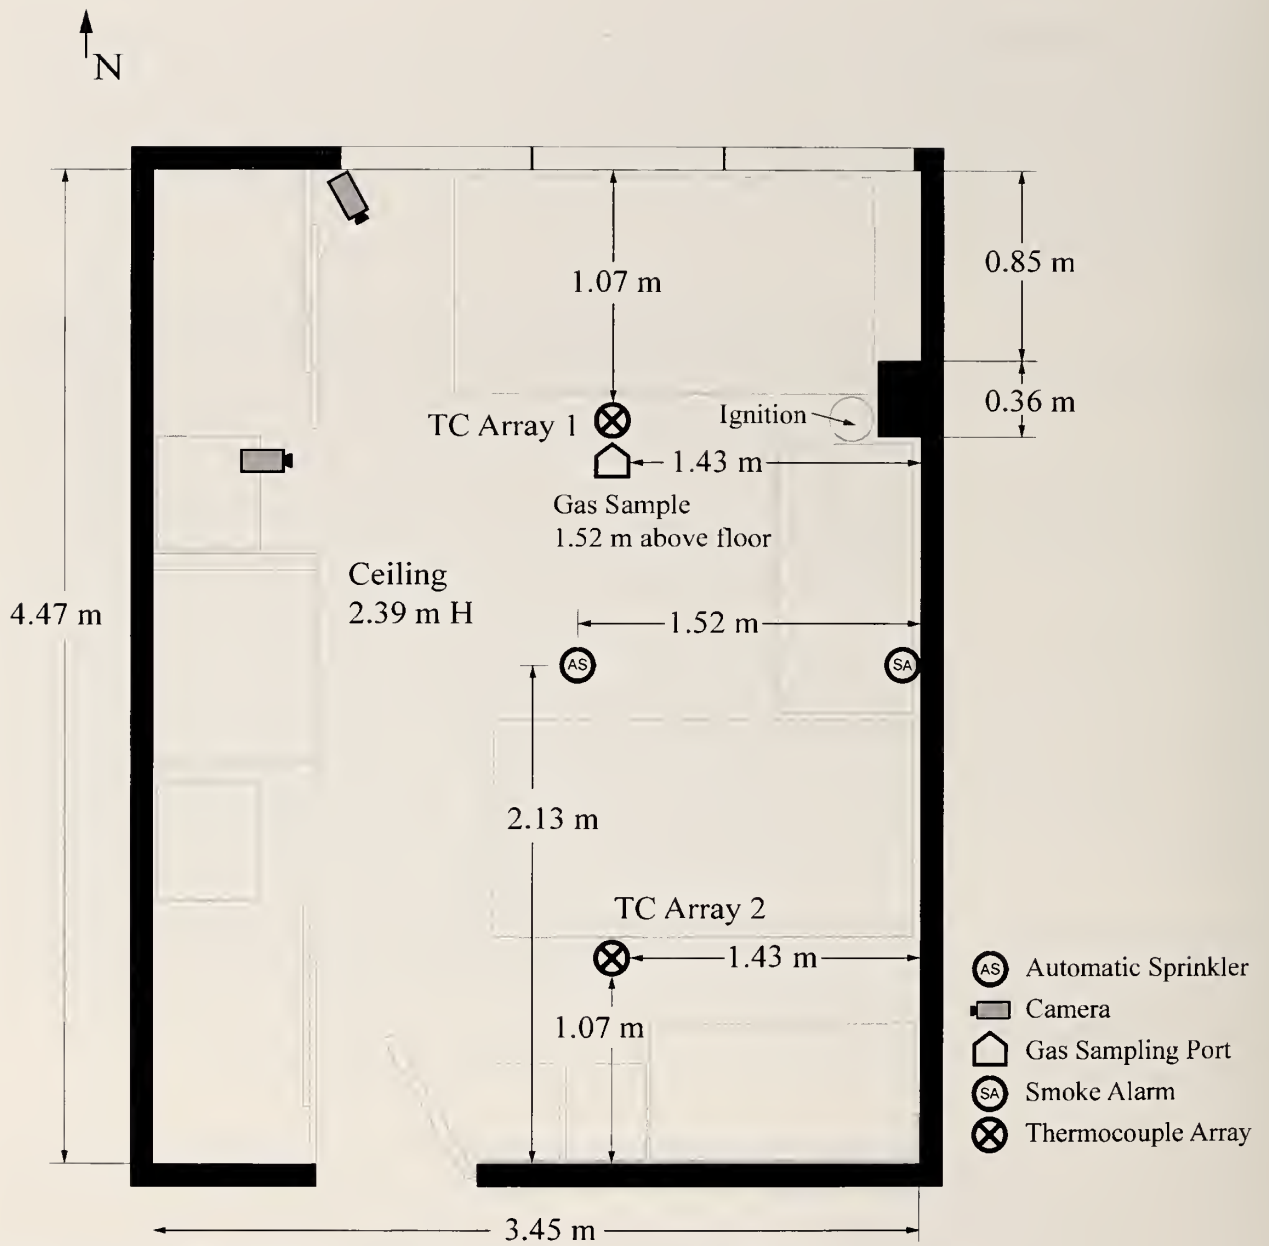
Figure 2.4-1. Floor plan of dorm room with instrumentation locations

Gas concentrations were sampled at two different positions. In each experiment, the sampling line inlets were located adjacent to TC Array 1 and TC Array 4 at 1.52 m (5.0 ft) above the floor. The sampling lines were connected to calibrated vacuum pumps which moved the gas samples through a conditioning system, which removed particulate and moisture from the gas sample.

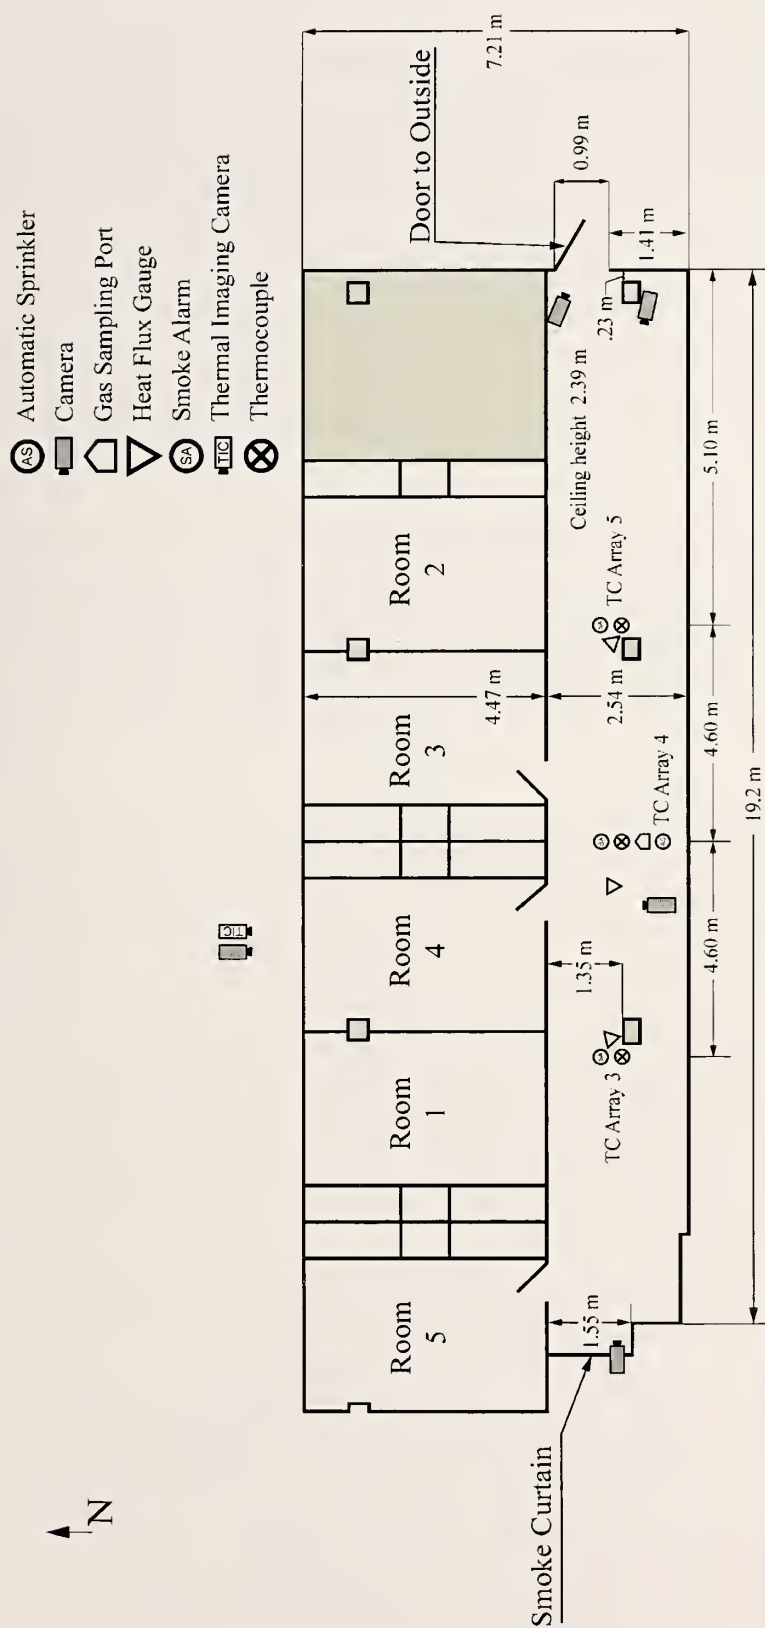
Figure 2.4-2. Floor plan of corridor with instrumentation locations

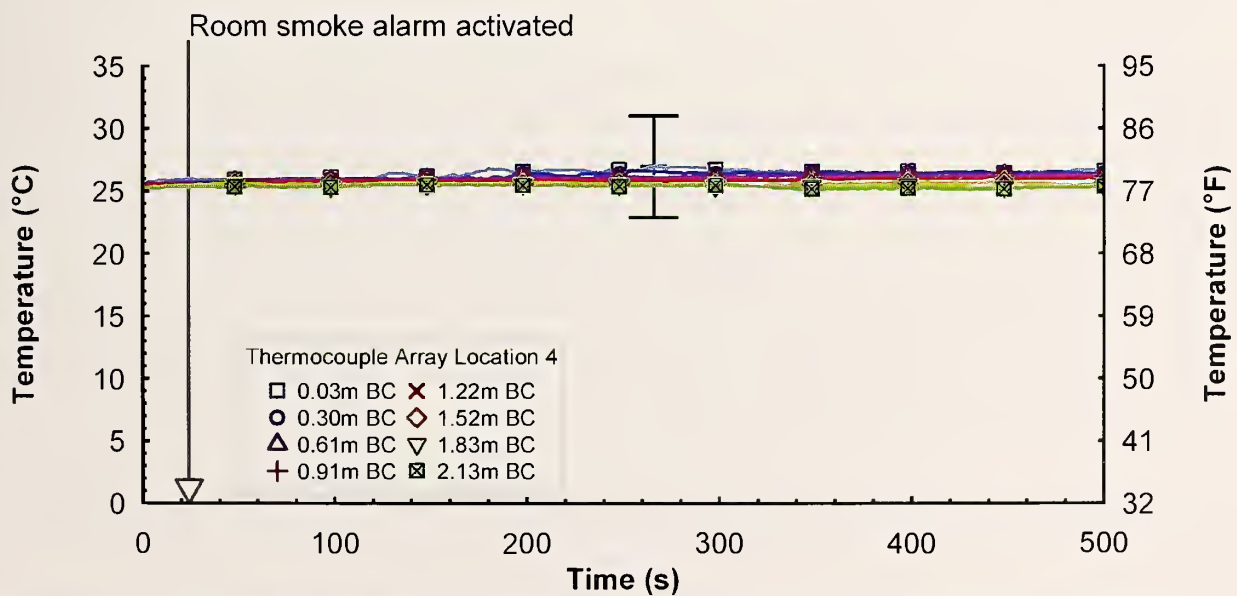
Figure 3.1-4. Temperature versus time data from thermocouple array 4 in Experiment 1, listed by distance below ceiling (BC)

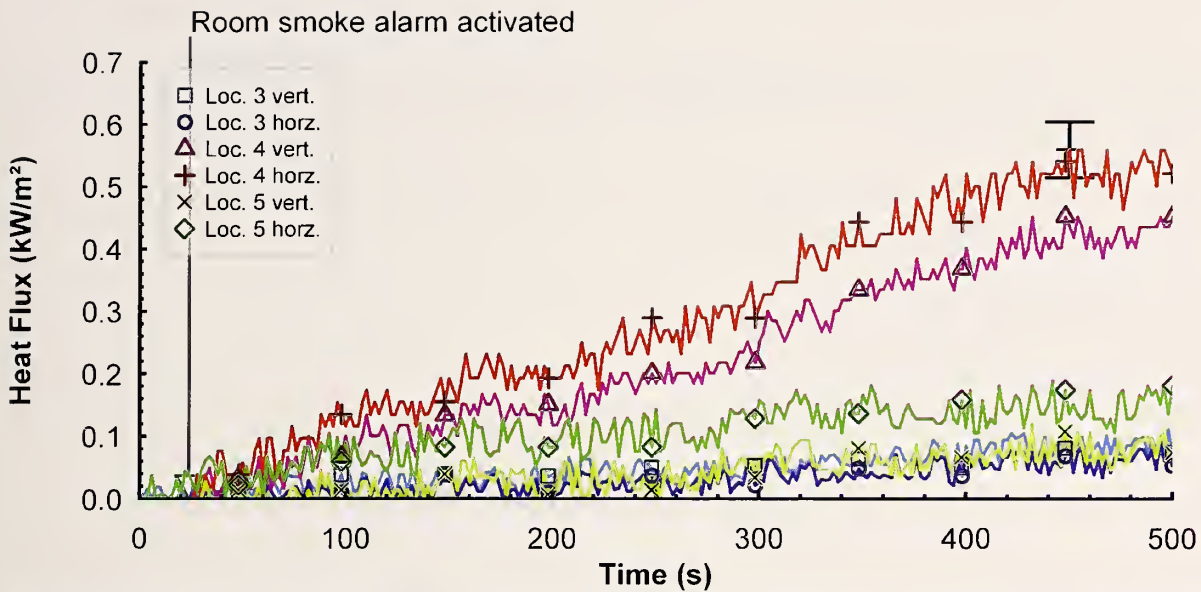
Figure 3.1-8. Heat flux versus time data for the heat flux gauges at locations 3, 4, and 5 in the orientations up (vert) and sideways (horz)

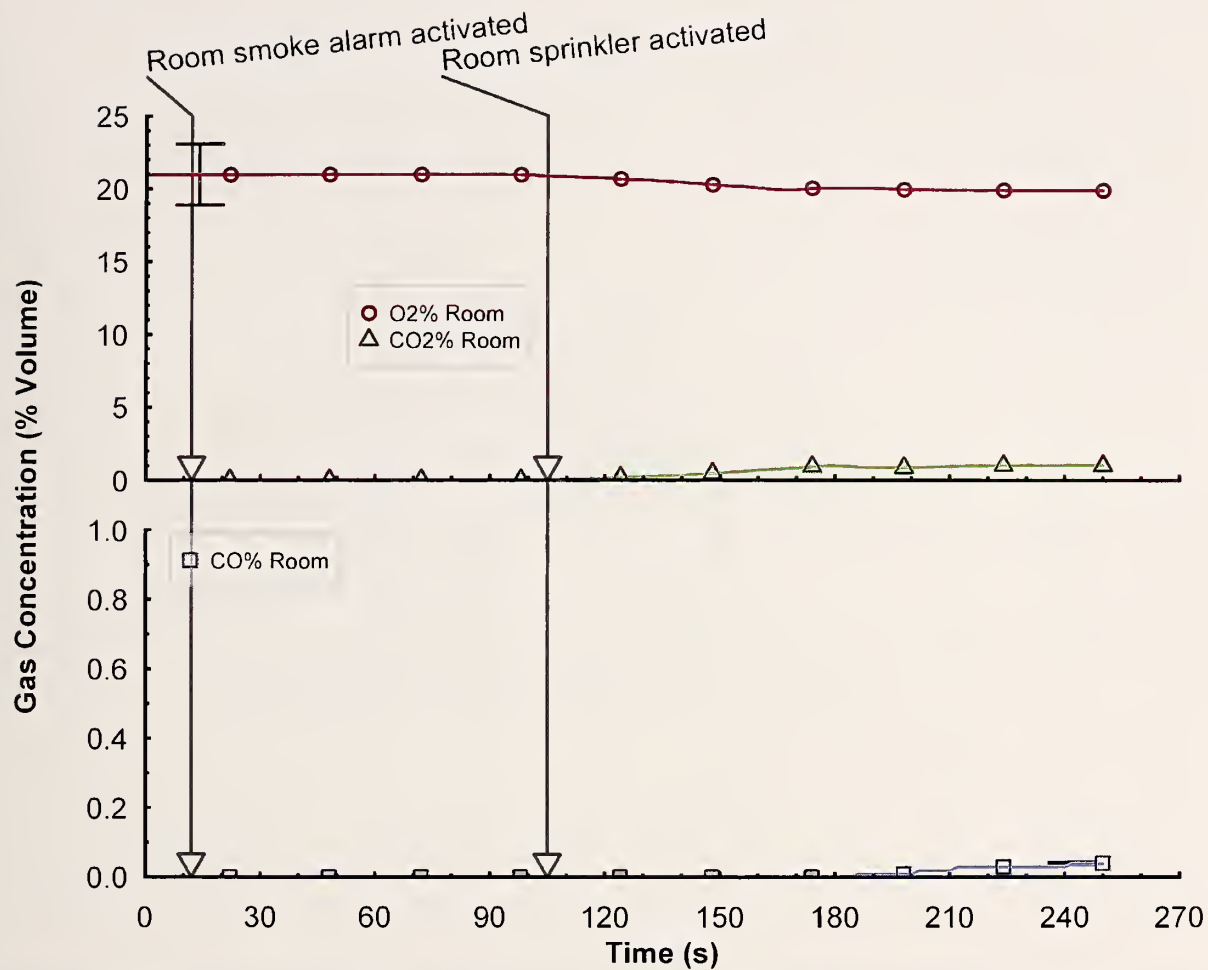
Figure 3.2-6. Relative gas concentrations versus time for the gas sampling at 1.52 m above the floor at location 1 in Experiment 2

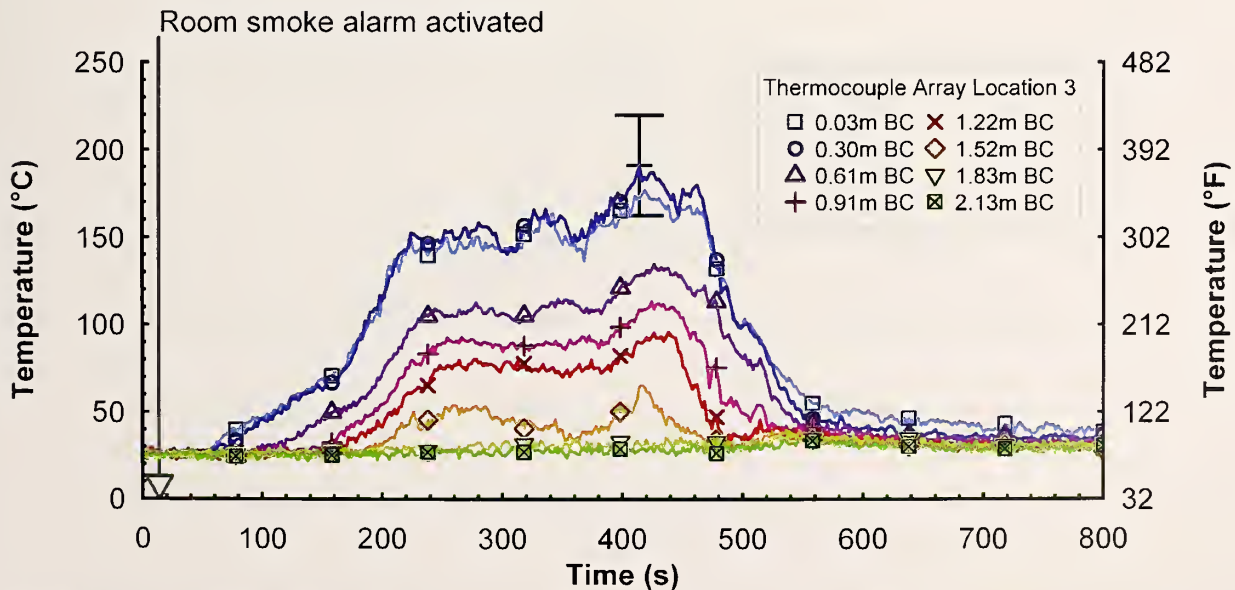
The corridor itself did not transition to flashover, as shown by the thermal gradient with a hot gas layer in the upper portion of the corridor and the near ambient temperatures in the lower portion of the corridor, as shown in Figure 3.4-3 through Figure 3.4-5. This condition began as hot combustion products entered the corridor and continued until suppression. Hence a fire fighter crouching 1.2 m (4.0 ft) or less above the floor as they approached the fire room would be exposed to temperatures of 100 °C (212 °F) or less.

Figure 3.4-3. Temperature versus time data from thermocouple array 3 in Experiment 4, listed by distance below ceiling (BC)

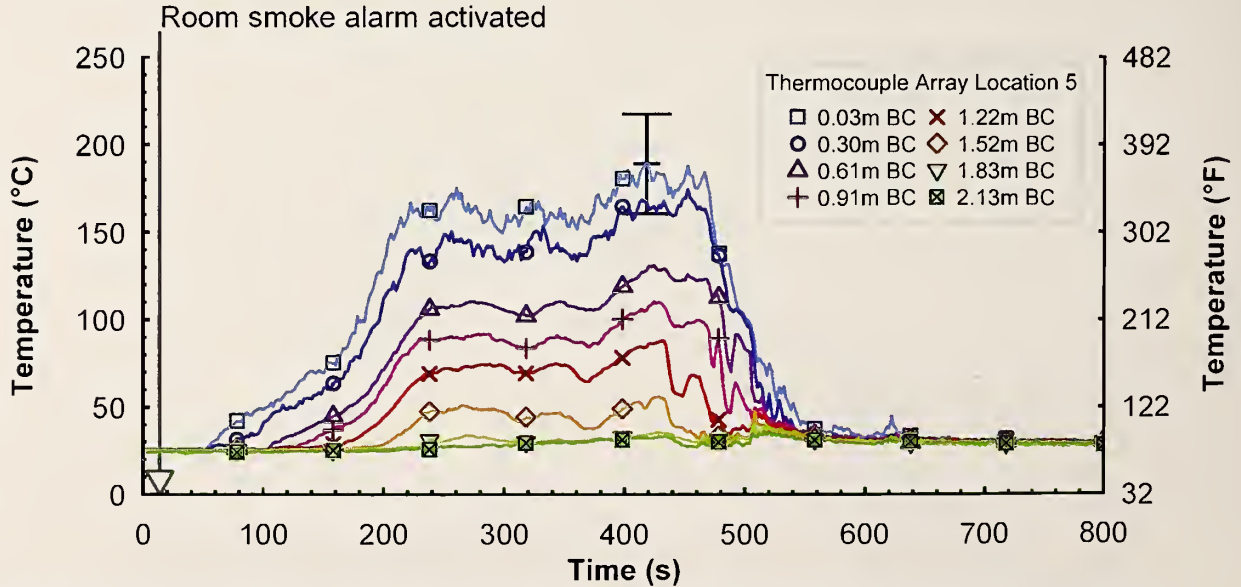
Figure 3.4-5. Temperature versus time data from thermocouple array 5 in Experiment 4, listed by distance below ceiling (BC)

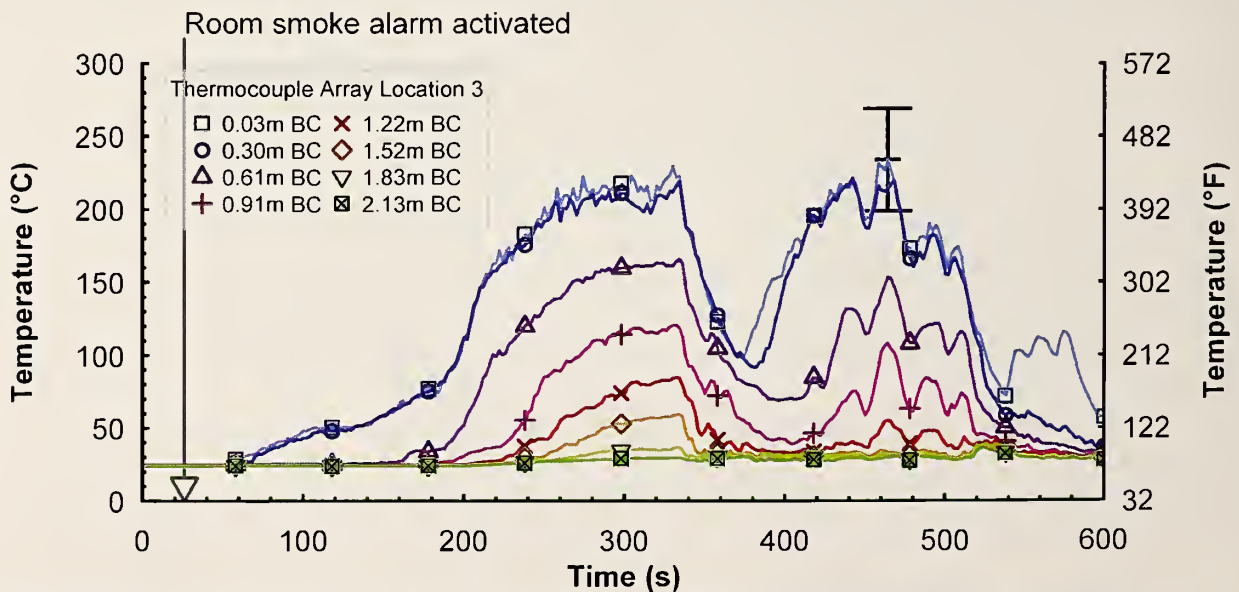
Figure 3.5-3. Temperature versus time data from thermocouple array 3 in Experiment 5, listed by distance below ceiling (BC)

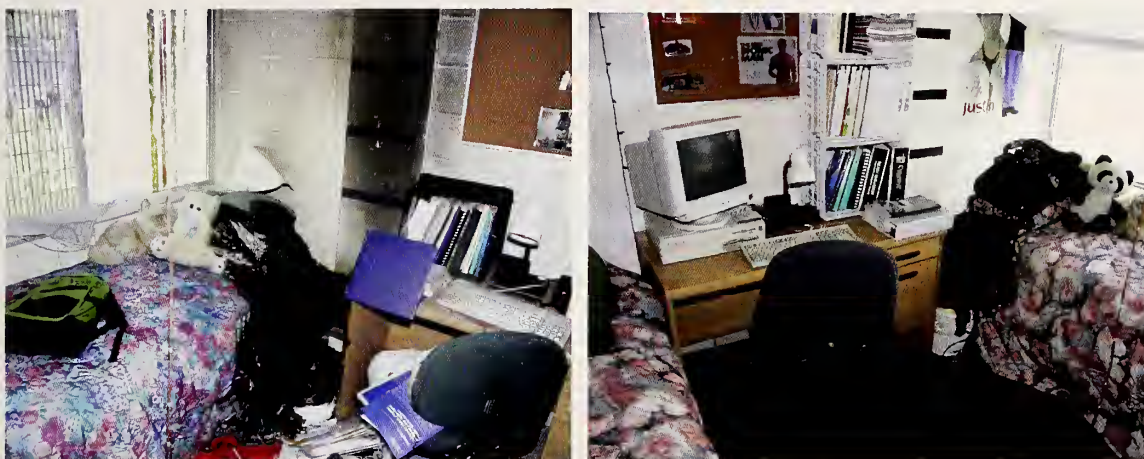
Figure 4.1-1. Post fire photographs of the dorm room for Experiment 1 (non-sprinklered) on the left and Experiment 2 (sprinklered) on the right.

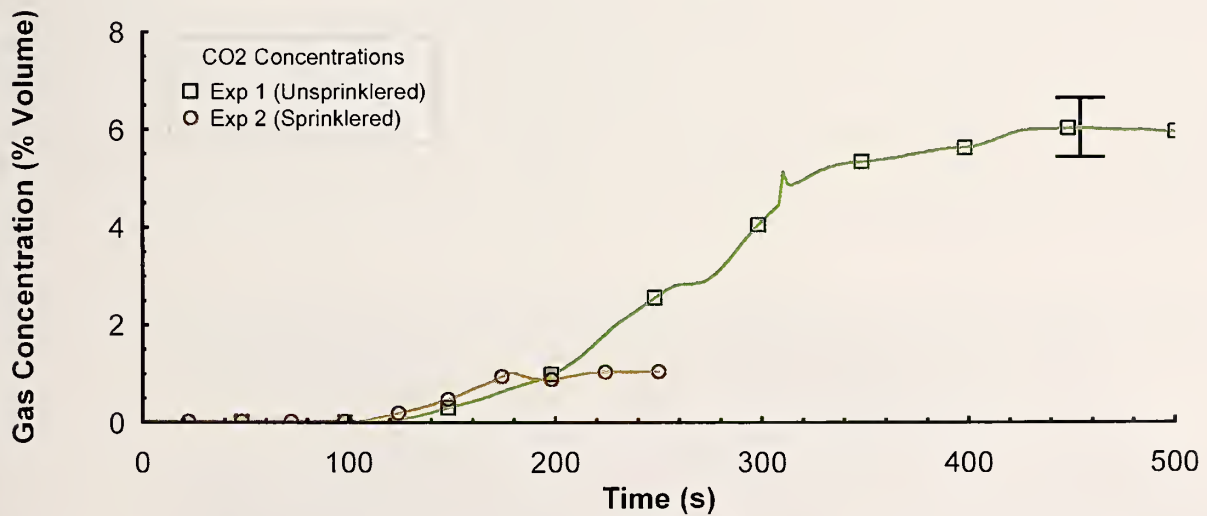
Figure 4.1-4. Carbon dioxide concentrations versus time in the dorm room from Experiment 1 and 2 at approximately 1.5 m (5 ft) above the floor.

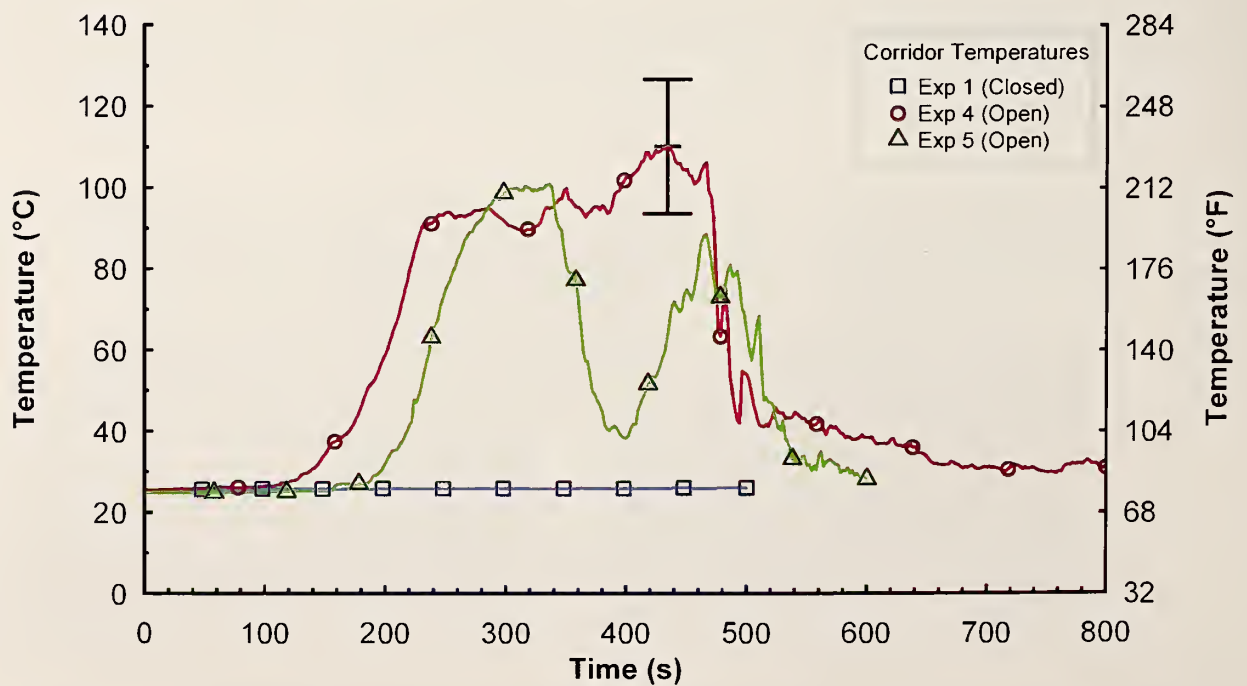
Figure 4.2-4. Temperature versus time data from thermocouple array 4 from Experiment 1, 4 and 5 at approximately 1.5 m (5 ft) above the floor.

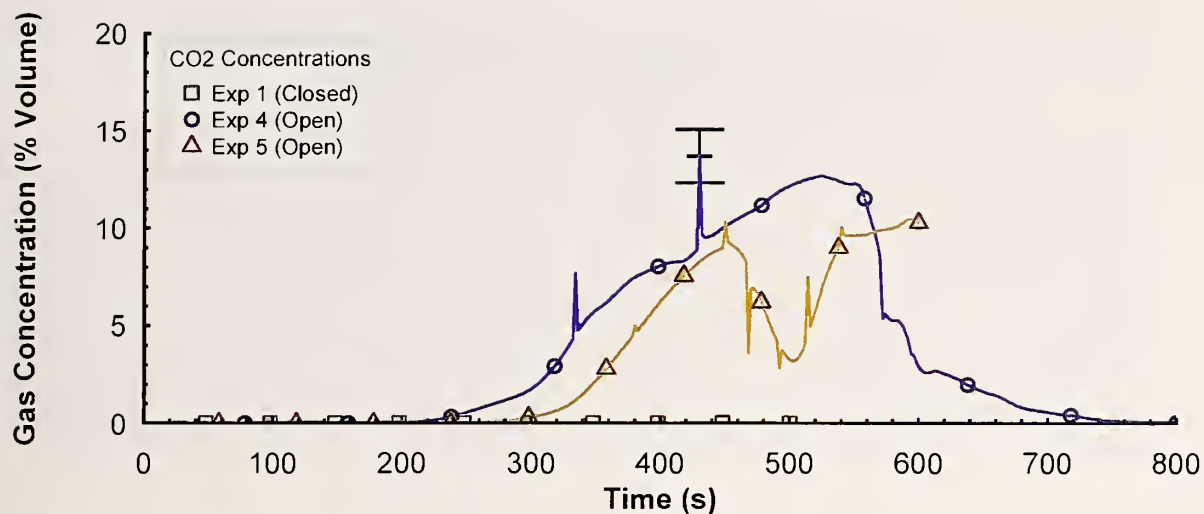
Figure 4.2-8. Carbon dioxide concentrations versus time in the corridor from Experiment 1, 4 and 5 at approximately 1.5 m (5 ft) above the floor.

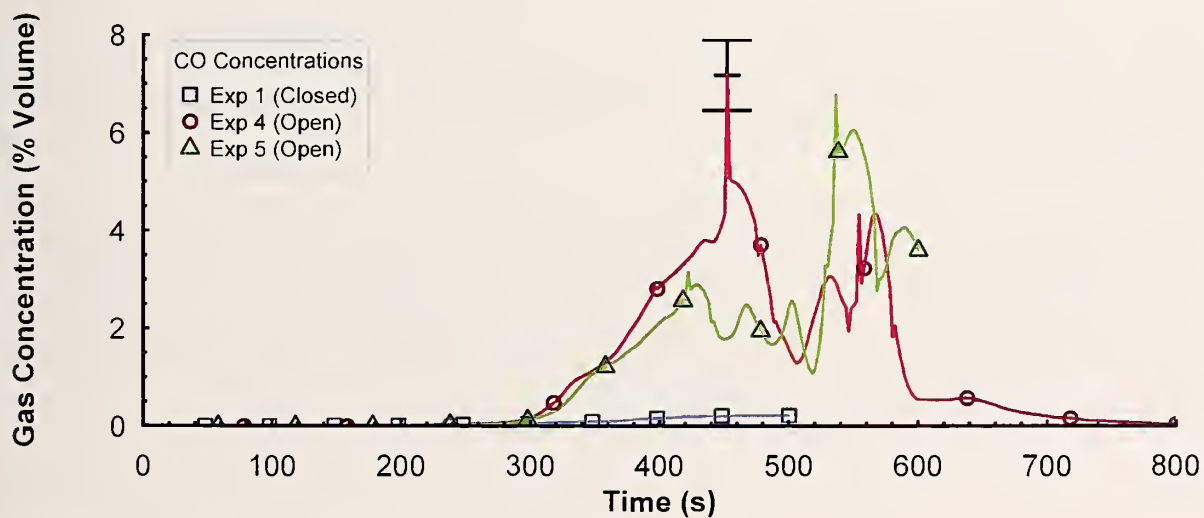
Figure 4.2-9. Carbon monoxide concentrations versus time in the dorm room from Experiment 1, 4 and 5 at approximately 1.5 m (5 ft) above the floor.

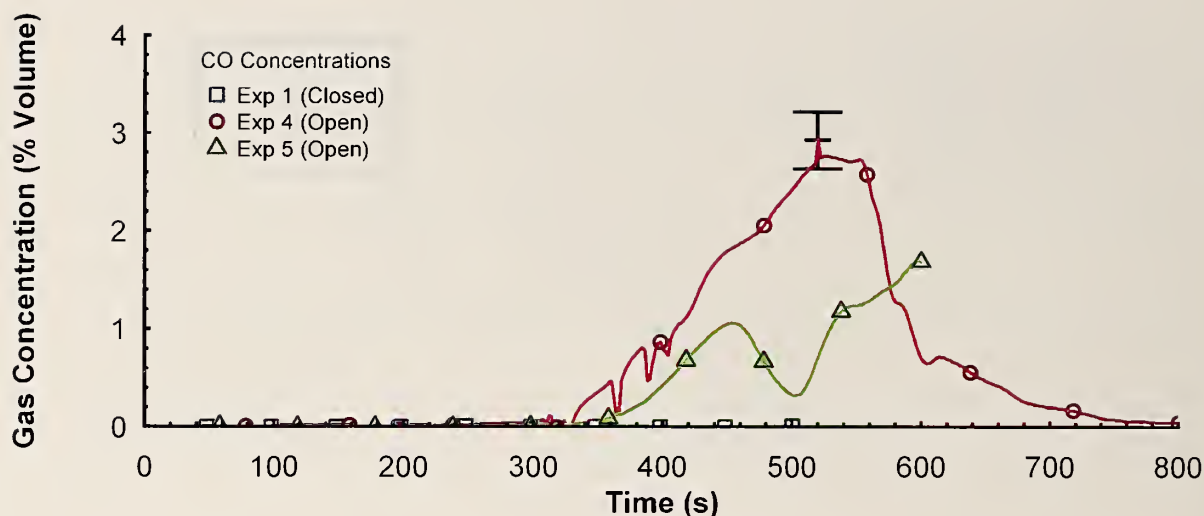
Figure 4.2-10. Carbon monoxide concentrations versus time in the corridor from Experiment 1, 4 and 5 at approximately 1.5 m (5 ft) above the floor.

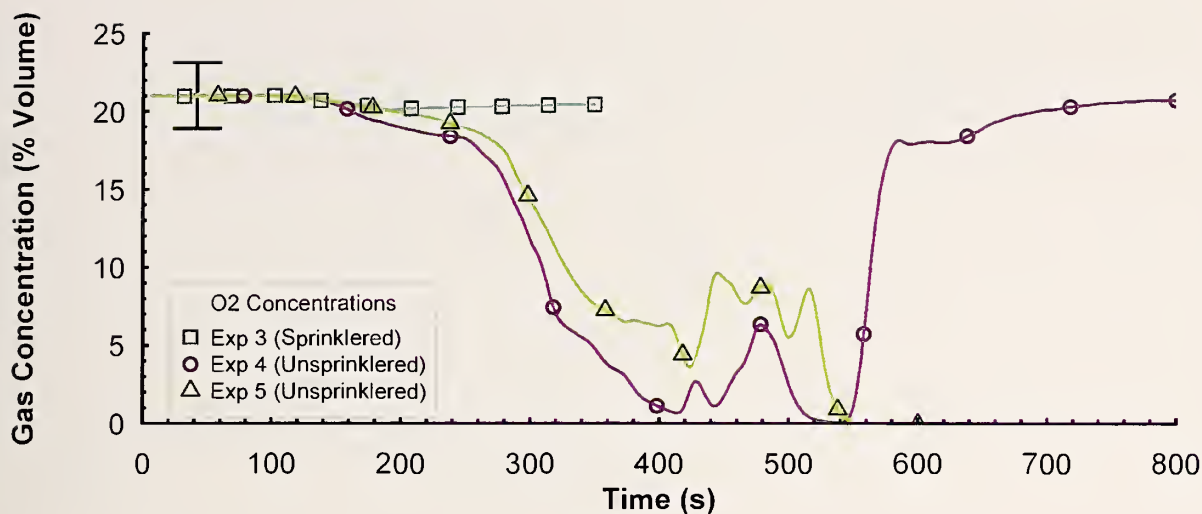
Figure 4.3-4. Oxygen concentrations versus time in the dorm room from Experiment 3, 4 and 5 at approximately 1.5 m (5 ft) above the floor.

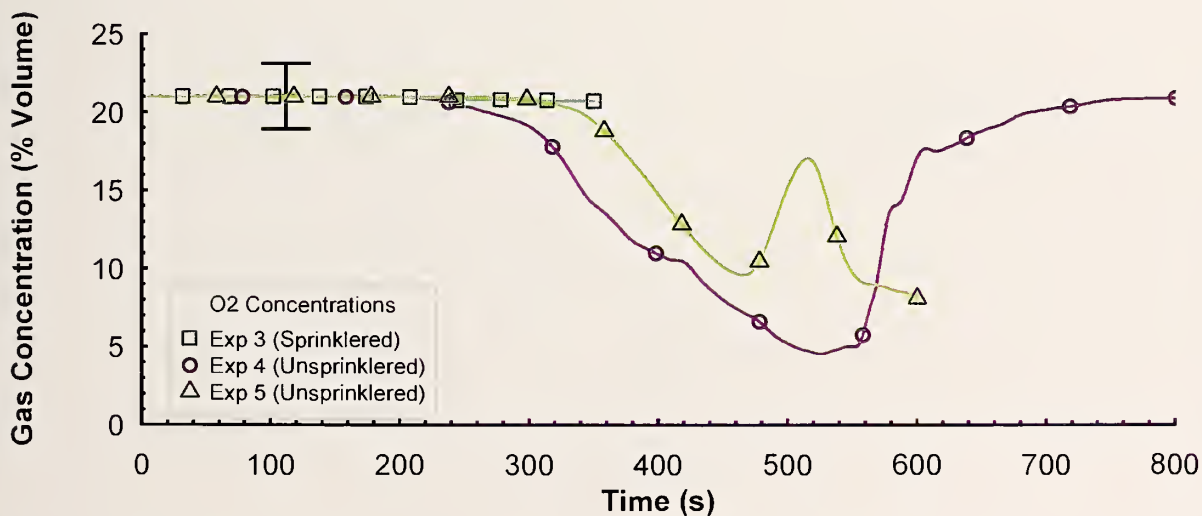
Figure 4.3-5. Oxygen concentrations versus time in the corridor from Experiment 3, 4 and 5 at approximately 1.5 m (5 ft) above the floor.

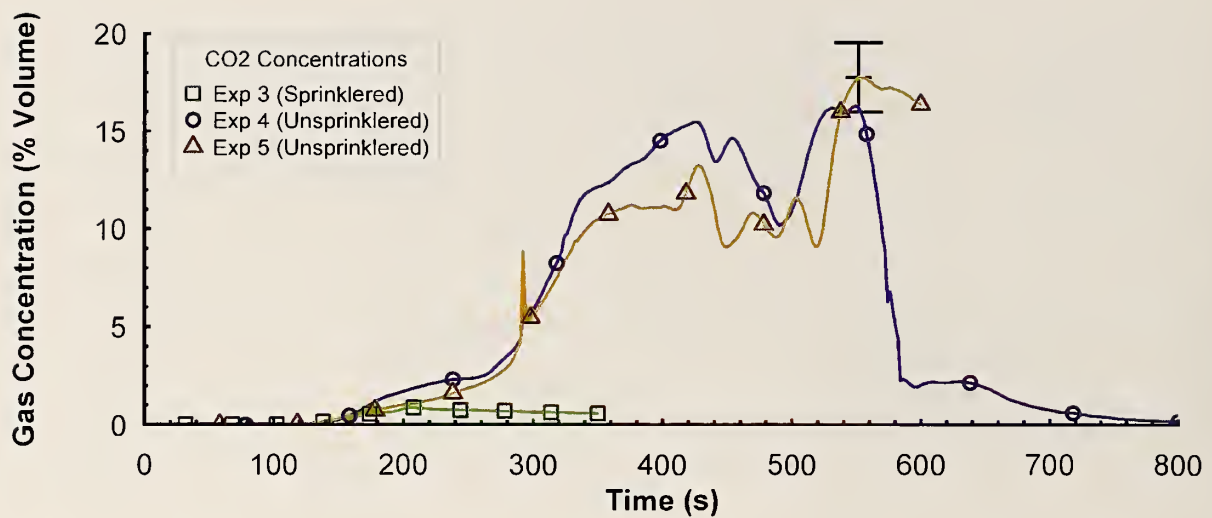
Figure 4.3-6. Carbon dioxide concentrations versus time in the dorm room from Experiment 3, 4 and 5 at approximately 1.5 m (5 ft) above the floor.

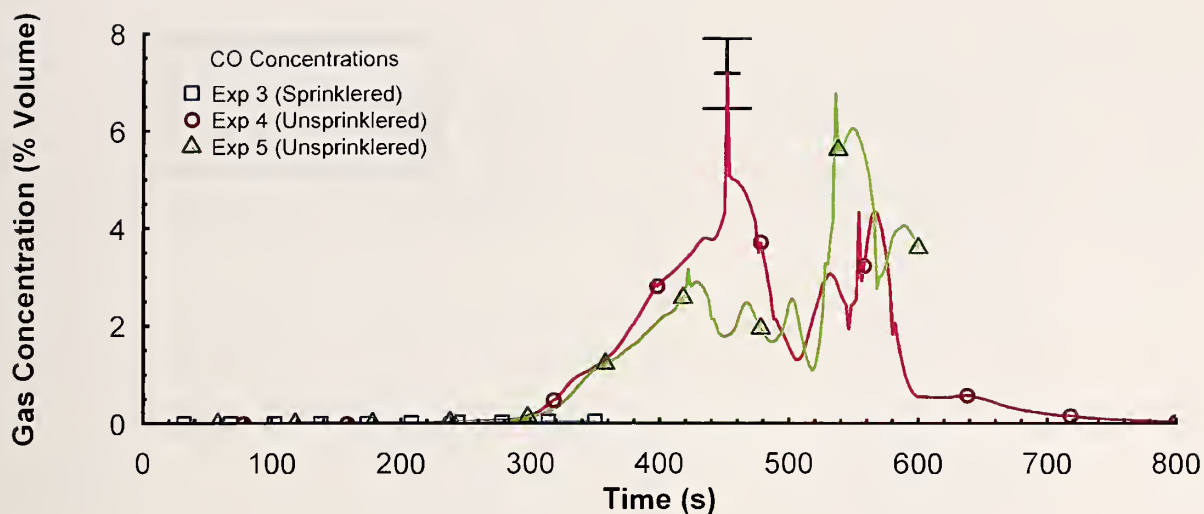
Figure 4.3-8. Carbon monoxide concentrations versus time in the dorm room from Experiment 3, 4 and 5 at approximately 1.5 m (5 ft) above the floor.

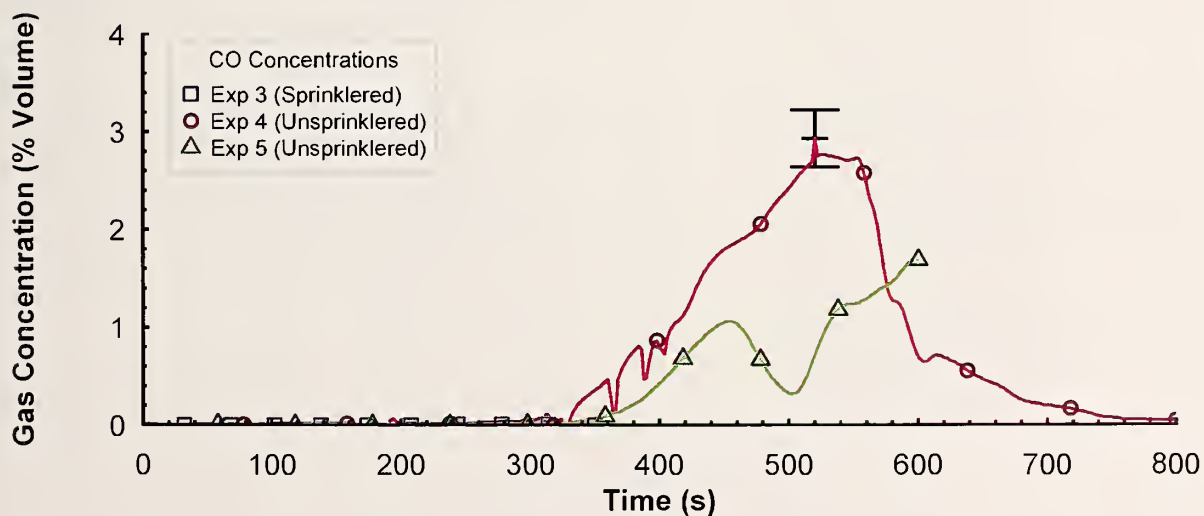
Figure 4.3-9. Carbon monoxide concentrations versus time in the corridor from Experiment 3, 4 and 5 at approximately 1.5 m (5 ft) above the floor.
